Technical Service Bulletin

No.JTB00146v4
28 April 2009

Subject/Concern : Diesel Particulate Filter (DPF) P2459, P244B, P2453, P2455 DTCs Stored

Models :		
S-TYPE	2.7L Diesel Only	2.7L Diesel Only VIN- range : N32679-N91220
XJ Range	2.7L Diesel Only	2.7L Diesel Only VIN- range : H00332 Onwards
XF	2.7L Diesel Only	2.7L Diesel Only VIN- range : R00001 Onwards

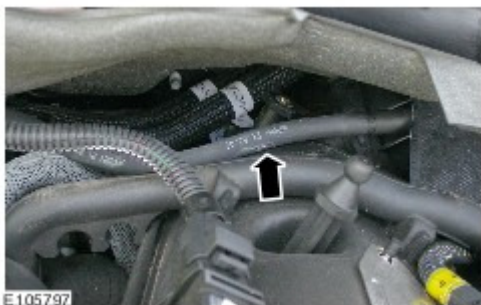
Inspect vacuum pipe routing to both left and right-hand valves, check for crushed (between the camshaft cover and the engine cover), damaged or kinked lines.

- 4 . If the vacuum hose is damaged or kinked (remove the same vacuum pipe from the supplied new vacuum hose assembly).
 - 1 . Install the new vacuum hose, ensuring it is correctly routed (see graphic E105798 in step 5).
- 5 . If the vacuum hose is trapped between the cam cover and the engine cover (not damaged or kinked), route at the back of the camshaft cover (see graphic E105798).

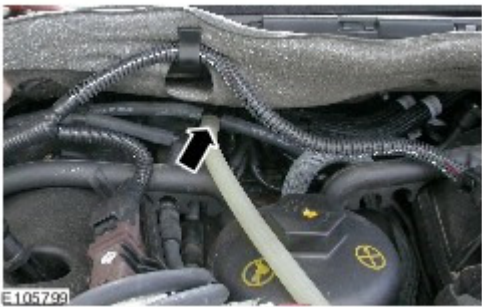
If there is no leak at the port deactivation valves, carry out steps 7 and 8 and return the vehicle to customer. If a leak is detected at the port deactivations valve(s), carry on from step 8.

- 6 . Check the operation of both port deactivation valves by removing the vacuum pipe 'T' (see graphic E105799) piece in the centre 'V' and drawing a vacuum (25 cm of Mercury, using a suitable vacuum gun) onto the valves.
 - 1 . If the vacuum leaks away rapidly, identify which bank has failed by individually applying a vacuum to the port deactivation valves. Ensure that both pipes from the 'T' pipe are connected correctly to the valve heads.

- 9 . If the port deactivation valve(s) has a leak, install new intake port deactivation diaphragms. Both diaphragms **must** be replaced using the repair kit (see Global Technical Reference GTR workshop manual, section 303-04 - Swirl Plate Actuator Diaphragms).
